Olin College of Engineering

Corrosive Failure of a VW Jetta Wolfsburg RXII Rim

Kat Brookshier, Erica Chin, Rachel Fox

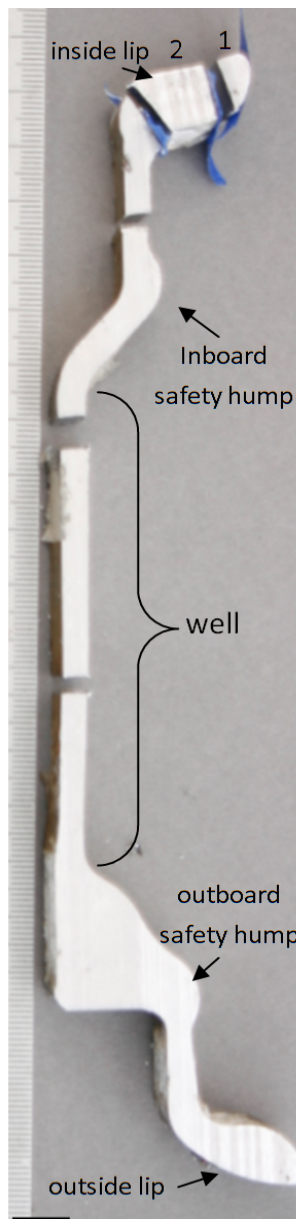
Figure 3: Terms used to reference parts of a rim. Scale bar = 1 cm. Labels 1 and 2 refer to samples used for cross-section surface examination.

Preliminary visual inspection of the rim after tire removal revealed peeling plastic coating and extensive white corrosion product concentrated between the edges of the rim and the safety humps, as shown in Figure 3. There was also a noticeable lack of corrosion products and surface ridges at the rim flange area. If not obscured by corrosion products, the surface of the rest of the rim displayed regular ridges, as shown in Figure 5.

4.2 Crevice Corrosion

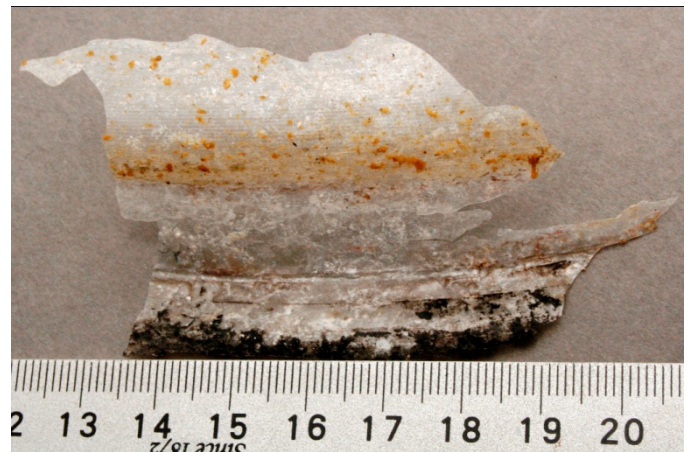
Figure 4: Flake of plastic coating from outer lip of rim.

Filiform corrosion occurs because of contamination on or poor preparation of the surfaces being coated. The nature of the metal substrate's surface is critical to proper adhesion between the substrate and the protective coating [15]. Aside from the presence of filiform corrosion, the detachment of the lacquer in the form of flakes, instead of chips, indicates that the lack of adhesion appears to be the most likely cause of failure of the coating [16].

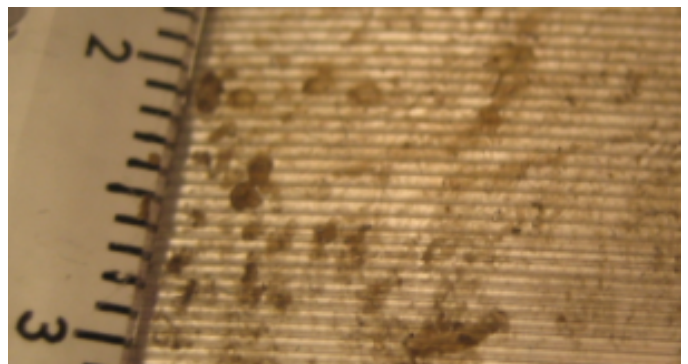
Figure 5: Flake of plastic coating from outer lip of rim.

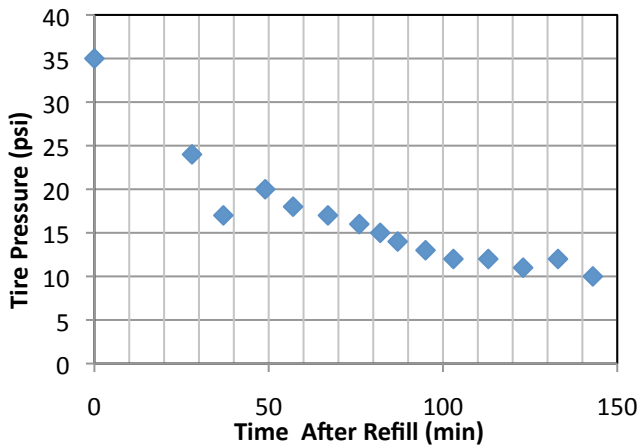
The tire pressure test confirmed rapid loss of pressure over time. The tire pressure dropped from 35 psi (a standard air pressure for the tire) to 10 psi in the span of two hours, as seen in **Error! Reference source not found.6**.

Figure 6: Graph showing air pressure loss from tire over the course of two and a half hours.

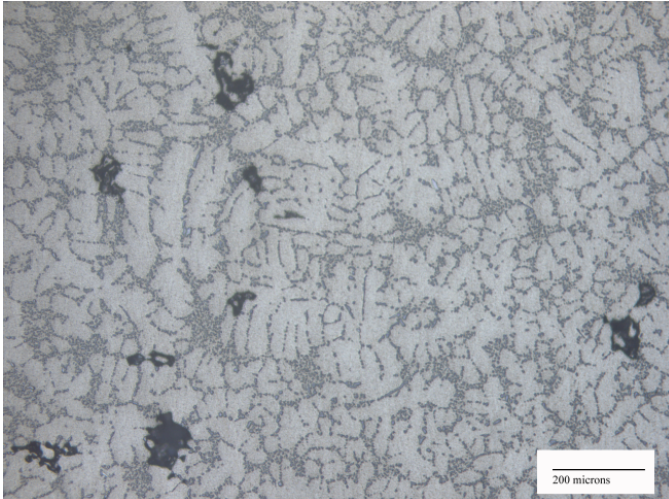
To confirm the hypothesis of a cast alloy, the microstructure of the metal was examined (Figure 8).

The dendritic structure and casting voids are definitive proof of a cast alloy as opposed to a wrought alloy.

Figure 8: Optical micrograph of a cross-sectional sample of the rim. The dendritic structure (light, aluminum solid solution) and eutectic solid regions (dark, speckled regions) indicate that the rim is a cast, hypoeutectoid Al-Si alloy. Dark areas are casting voids.

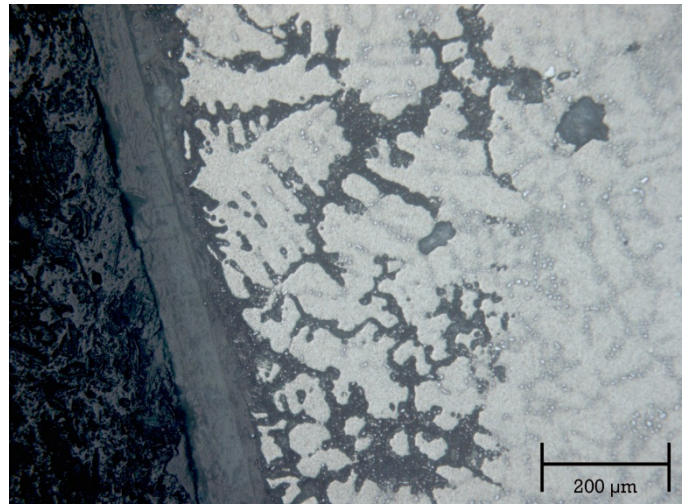
Optical microscopic analysis of a corroded sample revealed selective corrosion of the eutectic solid, or interdendritic, regions of the microstructure (Figure 10).

Figure 10: Optical micrograph of a cross-sectional sample from the edge of the corroded rim, showing intergranular corrosion in interdendritic regions.

Aluminum is known to form a thin, oxidative film on its surface which normally protects it from corrosion. In order for intergranular attack to occur, the corrosion solution must penetrate through this layer, or the layer must not be present. It is possible that there was no protective oxide layer in this case because the alloy was polymer coated. In this case, the filiform corrosion which caused the plastic coating to flake off could have exposed the surface of the alloy to an unfavorable environment, which would have allowed corrosion to occur. Exposing the alloy to some combination of road salt or abrasive cleaning chemicals and water because it no longer had a coating could have caused the intergranular corrosion observed.

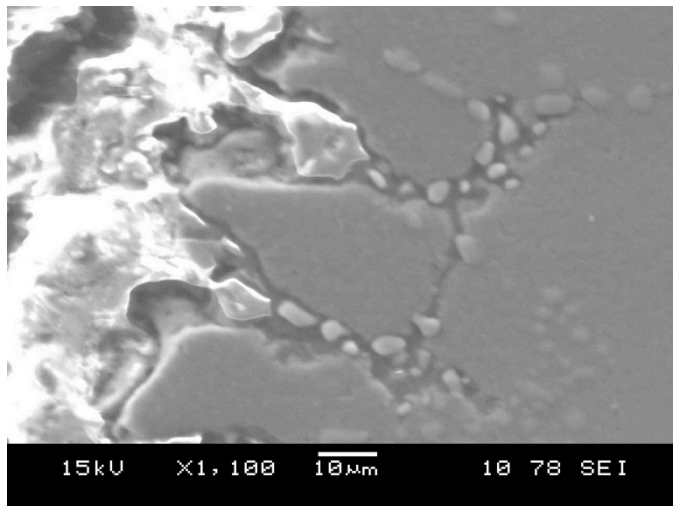
SEM analysis also showed that the corrosive solution had preferentially attacked the boundaries between the silicon and aluminum phases in the eutectic solid region of the alloy, as seen in Figure 12. The presence of some corrosion product on the surface of the metal was observed.

Figure 12: SEM micrograph of the corroded edge of the rim, showing that corrosion attacks aluminum eutectic phase, but not silicon. Corrosion product can be seen on the left (light areas).

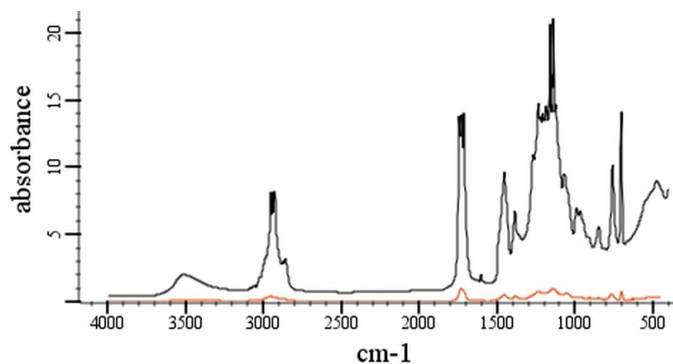
FTIR spectra of the removed film had the characteristic peaks of acrylic resins [10]. As lacquers, acrylics form coatings through the evaporation of solvents [10]. The sample was closely matched with Macrynal SM 510, as shown in Figure 13. Macrynal SM 510 is a resin used for clear top coats in automotive refinish coatings. Made by Cytec, this liquid resin is designed for weather durability and is advertised to meet the lowest volatile organic compound (VOC) requirement 420 g/l [11].

Figure 13: Peaks from the polymer coating sample (red) match those of acrylic resins, specifically Macrynal SM 510 (black).
