Olin College of Engineering

Corrosive Failure of a VW Jetta Wolfsburg RXII Rim

Kat Brookshier, Erica Chin, Rachel Fox

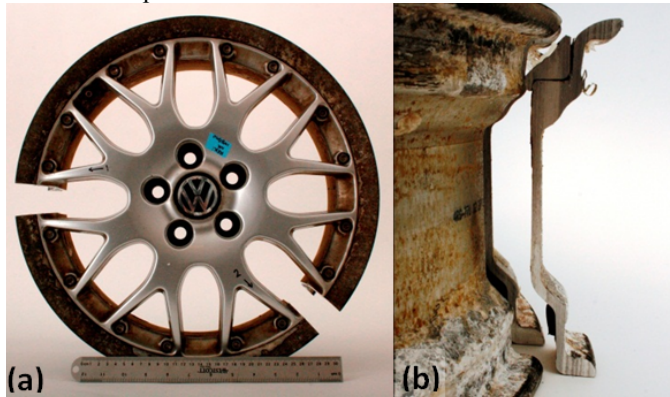
Figure 2: Cross-sectional cuts.

The variation of corrosion product concentration levels relative to corrosion product location on the rim was noted macroscopically. For ease of examination, a cross-sectional cut of the rim was made, as shown in Figure 2. Regions with greater presence of corrosion product were cut, as shown in Figure 3, for visual analysis on the cross-sectional surfaces at the microscopic level.

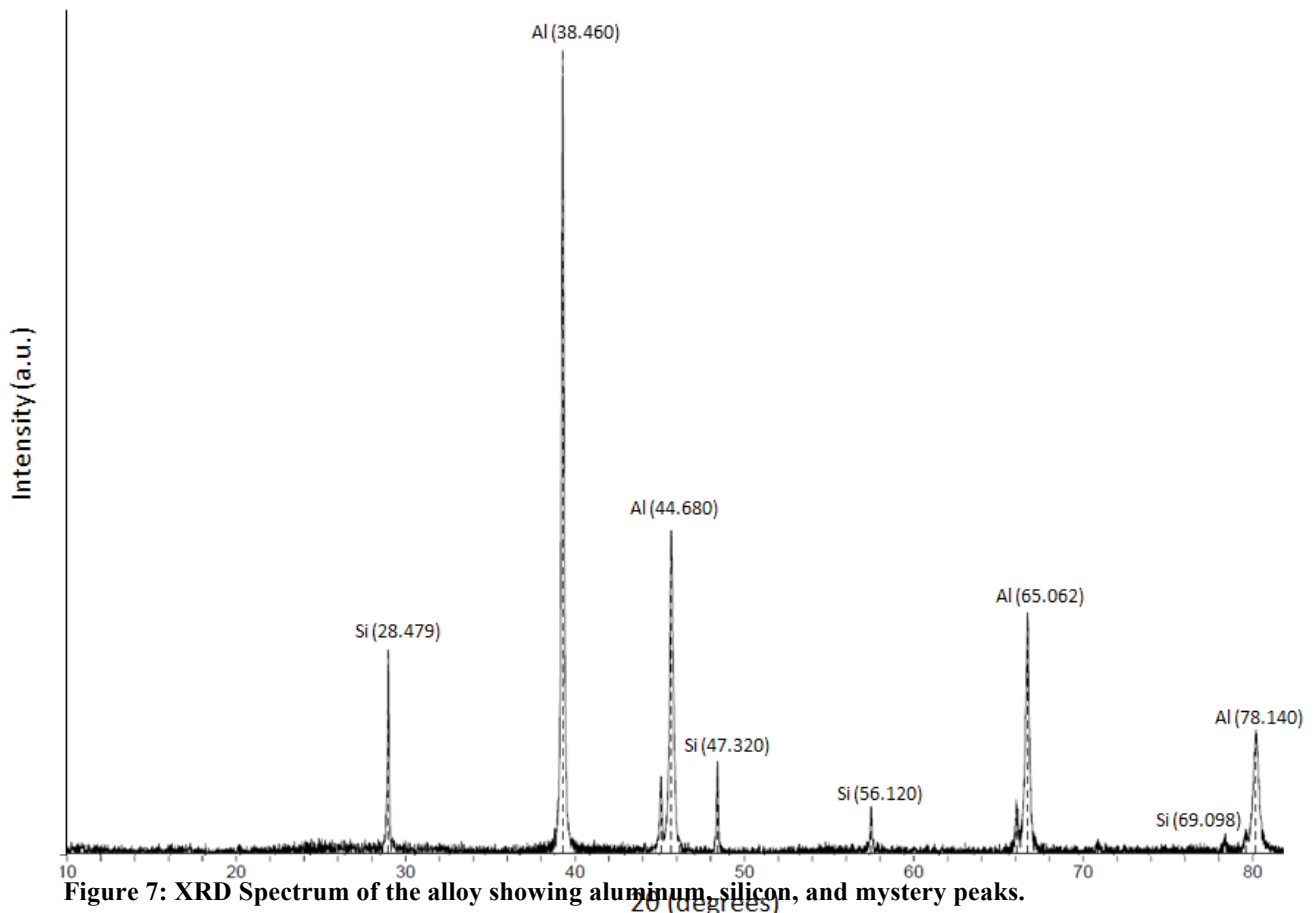
XRD showed that the rim was made from an aluminum-silicon alloy, with a composition of 84.8 weight percent aluminum, 8 weight percent silicon, and 7.2 weight percent of an unidentified element. Composition was determined using Jade’s Search/Match function as depicted in Figure 7, which identified large aluminum peaks, smaller

Figure 7: XRD Spectrum of the alloy showing aluminum, silicon, and mystery peaks.

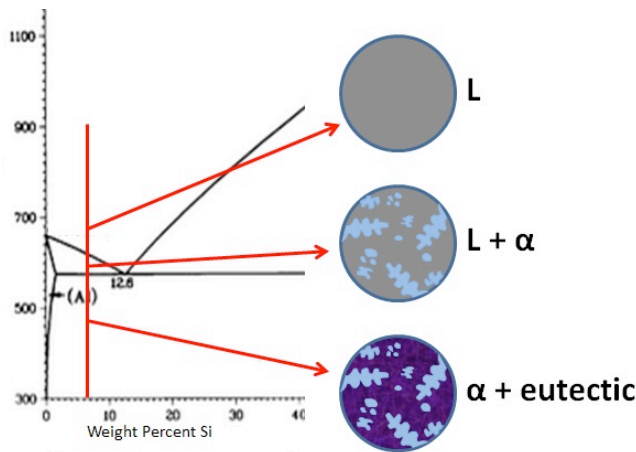
The microstructure is hypoeutectic, which is consistent with a composition between 1.6 and 12.6 weight percent silicon

Figure 9: The aluminum-silicon phase diagram and the formation of a hypoeutectic alloy. As the alloy cools, it passes through an $\alpha+L$ phase during which aluminum dendrites nucleate, and then passes over the eutectic line, resulting in a two phase eutectic matrix surrounding the dendrites.

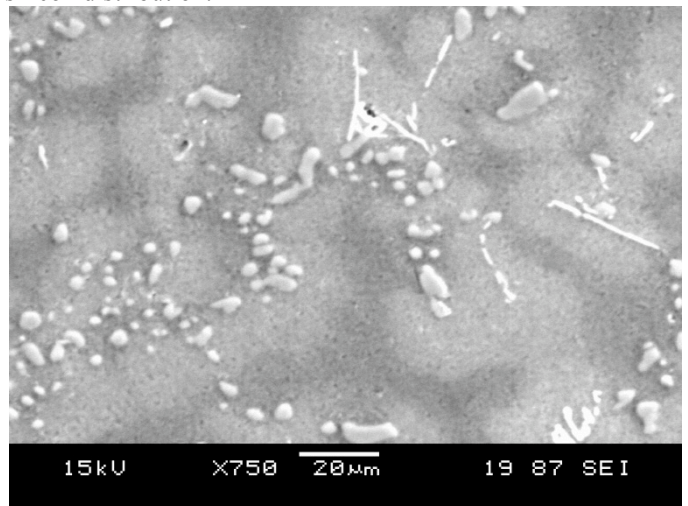
Scanning electron microscopy more clearly showed the two-phase $\alpha + \beta$ eutectic solid solution between the dendrites. The alpha phase is aluminum which contains approximately 1.6 weight percent silicon in solid solution. The beta phase is silicon which contains approximately 0.1 weight percent in solid solution.

The microscopy, Figure 11, also revealed the presence of silicon solid solution needles which are a result of solidification at the eutectic point (12.6 weight percent Si). These could be a result of non-equilibrium cooling or unequal silicon distribution.

Figure 11: Scanning electron micrograph of the cast rim alloy, showing aluminum solid solution dendrites (dark) with two-phase eutectic solid between dendrites. Light areas are the silicon solid solution phase.

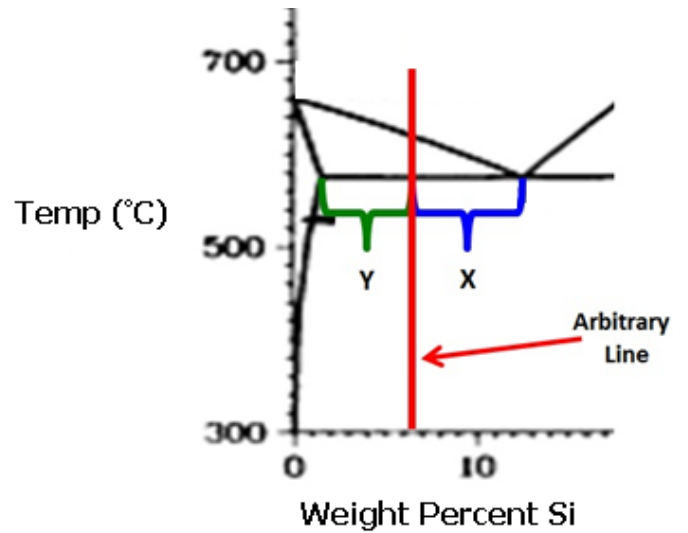
Referencing Figure 14, the lever rule was then used to estimate the initial aluminum weight percent based on this hypoeutectic structure.

$$.55 = \frac{12.6 - \text{Weight of } \beta}{12.6 - 1.6}$$

$$\text{Weight of } \beta = 6.55\%$$

Figure 14: The aluminum-silicon phase diagram, modified to show calculations.
